U.S. FISH AND WILDLIFE SERVICE NEW ENGLAND FIELD OFFICE SPECIAL REPORT FY08-NEFO-1-EC

Contaminant Sampling to Facilitate Dam Removals/Habitat Restoration in New England

FY08-NEFO-1-EC

June 2008

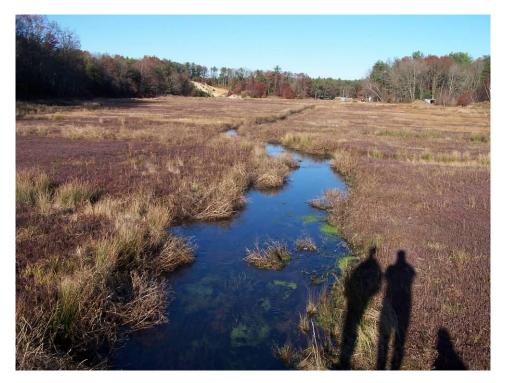
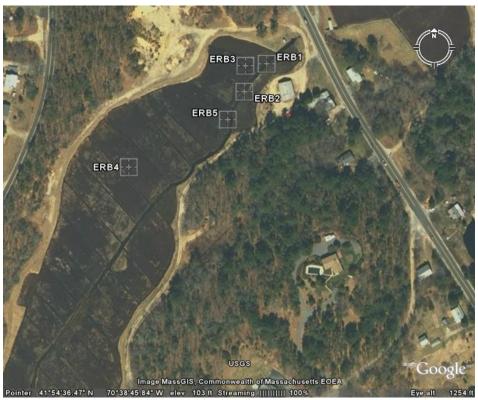
Figure 1. Eel River Bog and Sampling Locations

Metals: All results were below threshold effect levels.

Organics: Total DDE, Total DDT, and endrin sediment levels exceeded threshold effect levels in at least one sample. Total DDD, p,p-DDE, and dieldrin sediment levels exceeded probable effect levels in at least one sample.

PAHs: All results were below threshold effect levels.

Organophosphates/carbamates: All results were below threshold effect levels.

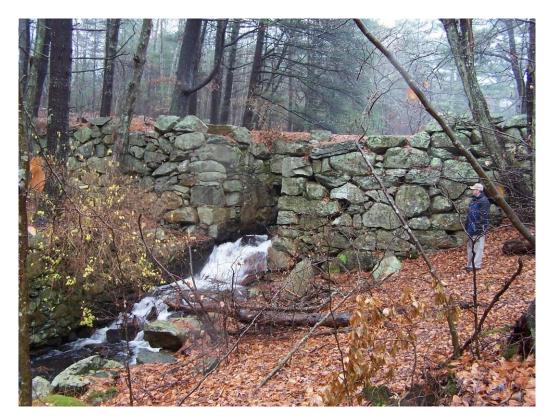
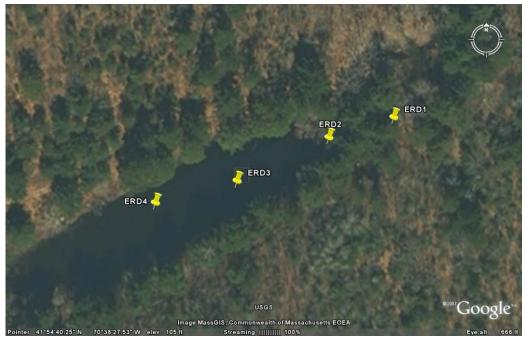
Figure 2. Eel River Dam and Sampling Locations

Metals: Arsenic, cadmium, and lead sediment levels exceeded threshold effect levels in at least one sample.

Organics: Total PCB sediment levels exceeded threshold effect levels in at least one sample. P,p-DDD, Total DDD, p,p-DDE, Total DDE, p,p-DDT, Total DDT, and dieldrin sediment levels exceeded probable effect levels in at least one sample.

PAHs: Anthracene, fluoranthene, benz[a]anthracene, chrysene, benzo[b]fluoranthene, benzo[k]fluoranthene, benzo[a]pyrene, dibenz[a,h]anthracene, and Total PAH sediment levels exceeded threshold effect levels in at least one sample. Phenanthrene and pyrene sediment levels exceeded probable effect levels in at least one sample.

inadvertently spreading the contaminated sediment downstream. There are times when a barrier to sediment transport has protected downstream habitat. A detailed review of the data from the Eel River Dam (Appendix III) reveals that while sediment samples from the impoundment had levels of DDT and its metabolites well above the probable effect levels, the downstream sample had only one constituent (p,p-DDE) above the threshold effect levels. Projects where sediment contaminant levels are elevated do not preclude removal of dam structures, but they do necessitate consideration of sediment abatement measures as part of the project planning process to accurately reflect the total cost of dam removal.

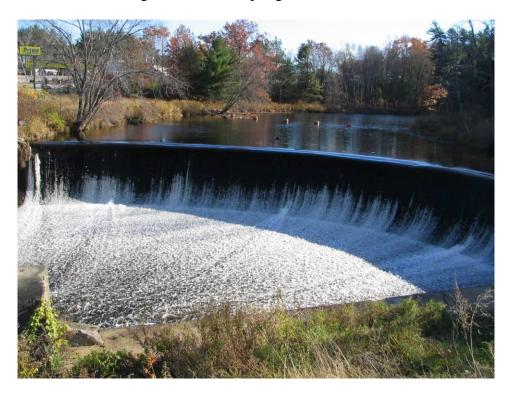
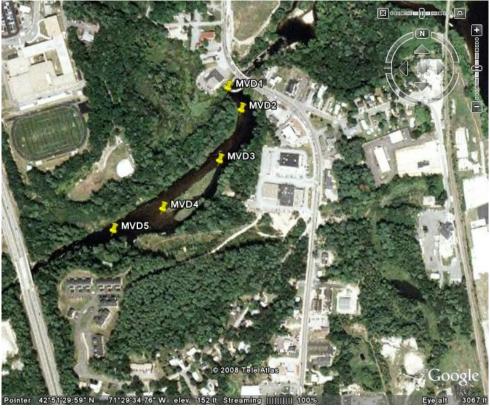
Figure 3. Merrimack Village Dam and Sampling Locations

Metals: All results were below threshold effect levels.

Organics: Total PCB sediment levels exceeded threshold effect levels in at least one sample.

PAHs: Pyrene, benz[a]anthracene, chrysene, benzo[b]fluoranthene, and Total PAH sediment levels exceeded threshold effect levels in at least one sample.

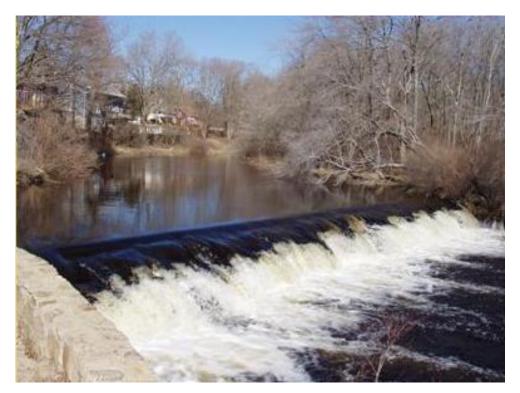
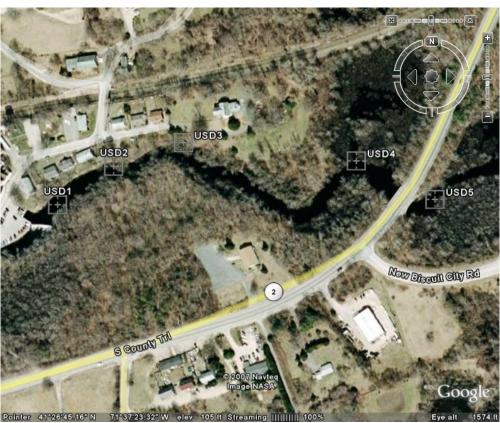
Figure 4. Kenyon Dam and Sampling Locations

Metals: Cadmium and lead sediment levels exceeded threshold effect levels in at least one sample.

Organics: Total DDD, p,p-DDE, Total DDE, and Total PCB sediment levels exceeded threshold effect levels in at least one sample.

PAHs: Anthracene, fluoranthene, pyrene, benz[a]anthracene, chrysene, benzo[b]fluoranthene, benzo[a]pyrene, dibenz[a,h]anthracene, and Total PAH sediment levels exceeded threshold effect levels in at least one sample. Phenanthrene sediment levels exceeded probable effect levels in at least one sample.

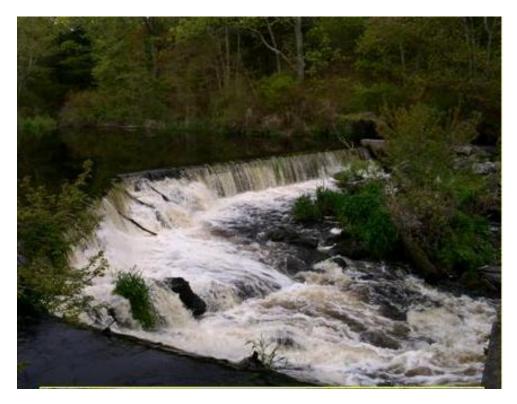
Figure 5. Lower Shannock Dam and Sampling Locations

Metals: Cadmium chromium, lead, and mercury sediment levels exceeded threshold effect levels in at least one sample.

Organics: P,p-DDD, Total DDD, and Total DDE sediment levels exceeded threshold effect levels in at least one sample. Total PCB sediment levels exceeded probable effect levels in at least one sample.

PAHs: Anthracene, benzo[b]fluoranthene, and dibenz[a,h]anthracene sediment levels exceeded threshold effect levels in at least one sample. Naphthalene, fluorine, phenanthrene, fluoranthene, pyrene, benz[a]anthracene, chrysene, benzo[a]pyrene, and Total PAH sediment levels exceeded probable effect levels in at least one sample.

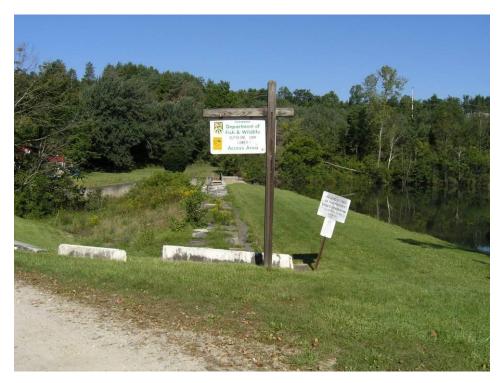
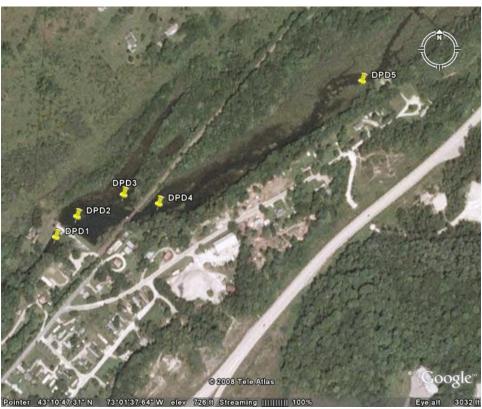
Figure 6. Dufresne Pond Dam and Sampling Locations

Metals: Cadmium, nickel, and zinc sediment levels exceeded threshold effect levels in at least one sample. Mercury sediment levels exceeded probable effect levels in at least one sample.

Organics: All results were below threshold effect levels.

PAHs: Phenanthrene, pyrene, benz[a]anthracene, chrysene, benzo[b]fluoranthene, and benzo[a]pyrene exceeded threshold effect levels in at least one sample.

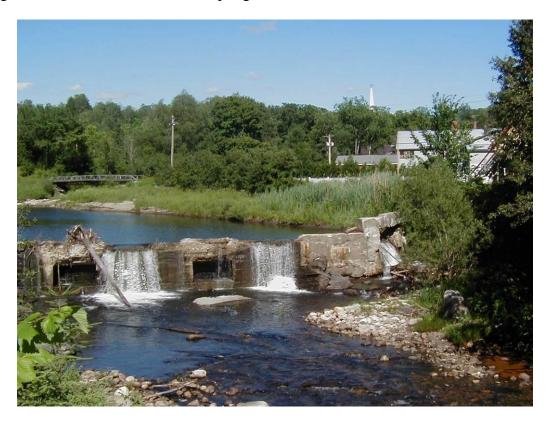
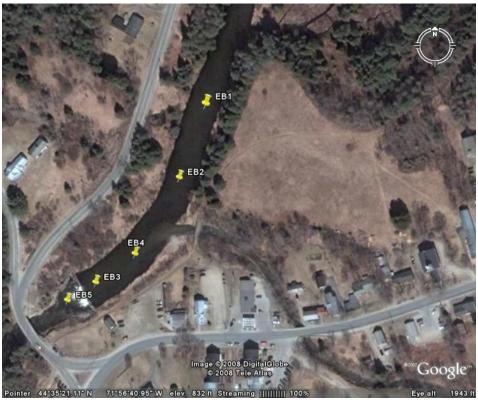
Figure 7. East Burke Dam and Sampling Locations

Metals: All results were below threshold effect levels.

Organics: All results were below threshold effect levels.

PAHs: All results were below threshold effect levels.

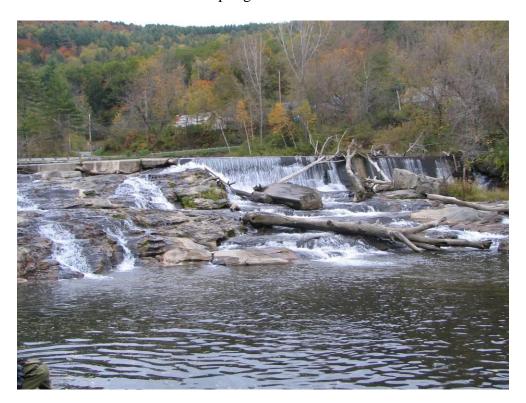
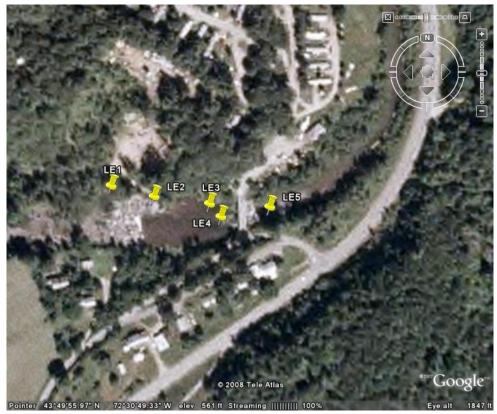
Figure 9. Lower Eaton Dam and Sampling Locations

Metals: Cadmium and nickel sediment levels exceeded threshold effect levels in at least one sample. Copper sediment levels exceeded probable effect levels in at least one sample.

Organics: All results were below threshold effect levels.

PAHs: Phenanthrene, pyrene, benz[a]anthracene, benzo[b]fluoranthene, and benzo[a]pyrene sediment levels exceeded threshold effect levels in at least one sample.
